**ASBESTOS MANAGEMENT SURVEY  
RE-INSPECTION REPORT**

**Holiday Inn Corby – Kettering  
Geddington Road, Corby, Northants, NN18 8ET**

Date **9<sup>th</sup> June 2015**

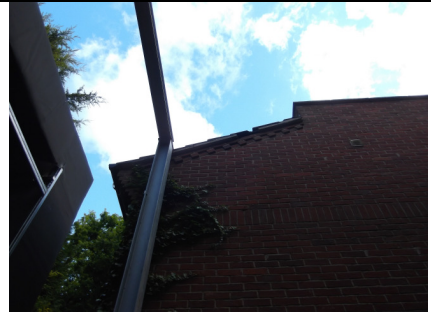
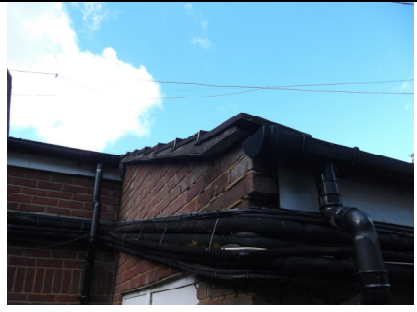
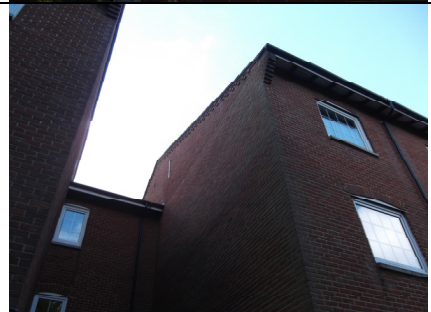
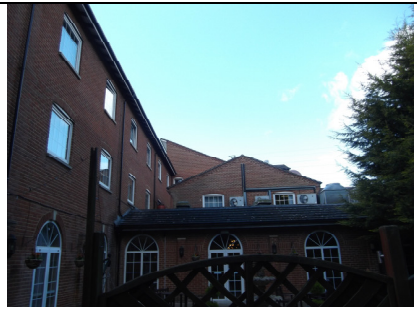
Report no/Sample Ref 150605/CAM/ S009 as (June 2008) report		Building/Floor External		Location/Room Roofline		Element Under-Cloaking

<p><b>RISK ASSESSMENT SCORE</b></p> <p><b>E</b></p> <p><u><i>Samples analysis performed previously</i></u></p>

Asbestos Type		Product Type		Damage		Surface Treatment		Total
Chrysotile	1	Asbestos Reinforced Composites	1	None	0	Bonded	0	
Amosite	2	Asbestos Insulating Board	2	Low	1	Sealed AIB, Unsealed cement	1	
Crocidolite	3	Thermal Insulation	3	Medium	2	Unsealed AIB, Sealed Lagging	2	
				High	3	Unsealed Lagging, Spray	3	
<b>Result</b>	<b>1</b>		<b>1</b>		<b>1</b>		<b>1</b>	<b>4</b>
<b>Minimum Recommendation</b>		<b>Manage &amp; Maintain product. Do not drill into, abrade, cut or otherwise disturb. Inspect regularly for signs of wear or damage. Ensure contractors visiting site are aware of its presence</b>

It can be concluded that the positively identified Asbestos Containing Material in situ at the site was Asbestos Cement **Under-Cloaking** to the majority of Rooflines. This was previously sampled and proven to contain Chrysotile. It was inspected by us during the course of this re-inspection visit, and was rated Priority **E** during Risk Assessment: In our opinion it is *unlikely to be a cause for concern (unless subjected to excessive wear or sudden damage)*. Therefore our minimum recommendation for this product is **Manage & Maintain**. Do not drill into it; abrade, cut or otherwise disturb it. Inspect it regularly for signs of wear or damage. Ensure contractors visiting the site are aware of its presence.

<b>Sample No:</b> <b>S009</b>	<b>Element &amp; Location:</b> <b>Under-Cloaking to External Roofline</b>
<b>Recommendation for S009:</b> <b>Manage &amp; Maintain product. Do not drill into, abrade, cut or otherwise disturb. Inspect regularly for signs of wear or damage. Ensure contractors visiting site are aware of its presence</b>

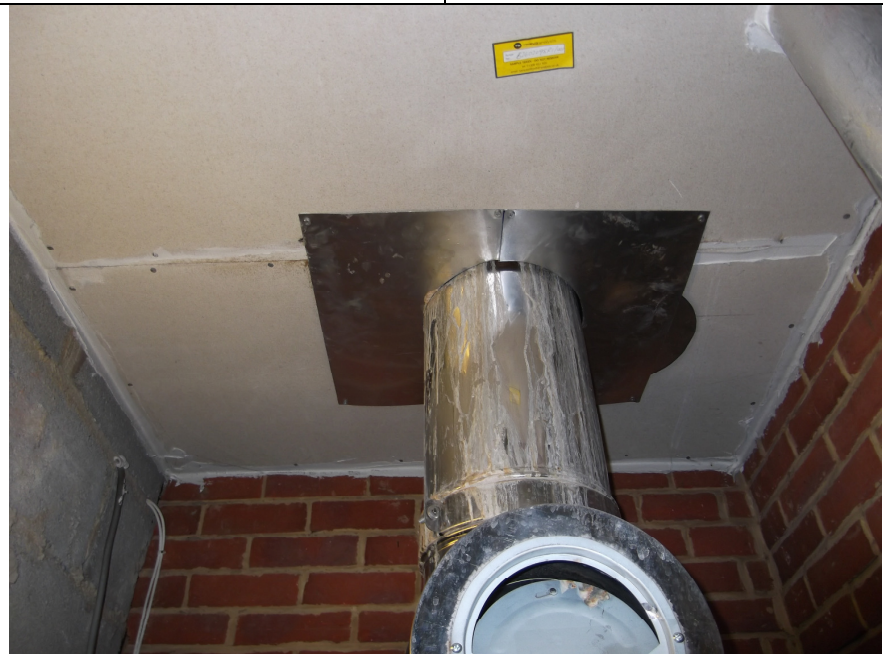
Report no/Sample Ref	Building/Floor	Location/Room	Element	
150605/CAM/S001	Ground Floor	Room 417 Store (Small Plant Room)	Panelling to Ceiling

<h1>RISK ASSESSMENT SCORE</h1> <h1>NAD</h1>		
Asbestos Type	Product Type	Damage	Surface Treatment	Total
Chrysotile	1 Asbestos Reinforced Composites	1 None	0 Bonded	0
Amosite	2 Asbestos Insulating Board	2 Low	1 Sealed AIB, Unsealed cement	1
Crocidolite	3 Thermal Insulation	3 Medium	2 Unsealed AIB, Sealed Lagging	2
		High	3 Unsealed Lagging, Spray	3
<b>Result</b>	<b>0</b>	<b>0</b>	<b>0</b>	<b>0</b>
<b>Minimum Recommendation</b>	<b>No asbestos detected in sample</b>

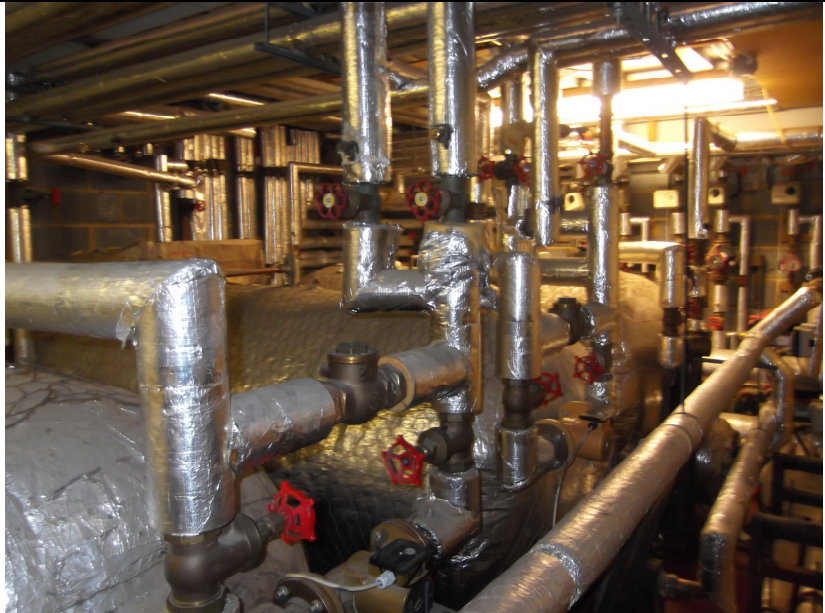
Report no/Sample Ref 150605/CAM/ Strongly Presumed A		Building/Floor Ground Floor		Location/Room Room 417 Store (Small Plant Room)		Element Gaskets to Pipework

<p><b>RISK ASSESSMENT SCORE*</b>  <b>*Not applicable</b>  <b><i>Strongly Presumed ACM</i></b></p>					
				Asbestos Type		Product Type		Damage	
Chrysotile	1	Asbestos Reinforced Composites	1	None	0	Bonded	0		
Amosite	2	Asbestos Insulating Board	2	Low	1	Sealed AIB, Unsealed cement	1		
Crocidolite	3	Thermal Insulation	3	Medium	2	Unsealed AIB, Sealed Lagging	2		
				High	3	Unsealed Lagging, Spray	3		
<b>Result</b>	-		-		-		-	<b>N/A</b>	
<b>Minimum Recommendation</b>		<p><b>Manage &amp; Maintain product. Do not drill into, abrade, cut or otherwise disturb. Inspect regularly for signs of wear or damage. Ensure contractors visiting site are aware of its presence</b></p>

During the course of the visit a brief inspection of the areas toured by ourselves was also undertaken as requested by the client. A sample was taken from the **Ground Floor Room 417 (small plant room) Ceiling**; however this was proven to be a **Non-Asbestos Containing Material**, however **Gaskets to the Pipework** through-out plant rooms were **Strongly Presumed** to be ACM's, as it was not possible to sample any of these as all services were live at the time of the survey. Our recommendation for these products is again **Manage & Maintain**. Do not drill into, abrade, cut or otherwise disturb them. Inspect them regularly for signs of wear or damage. Ensure contractors visiting site are aware of their presence.

<b>Strongly Presumed A: ACM's to Pipework to Rm 417 Store (Small Plant Room), Ground Floor</b>
<b>Recommendation for Strongly Presumed A:</b> <b>Manage &amp; Maintain product. Do not drill into, abrade, cut or otherwise disturb. Inspect regularly for signs of wear or damage. Ensure contractors visiting site are aware of its presence</b>
